The Adana-Ceyhan Earthquake of June 27, 1998

**Report on the Reconnaissance Mission from July 6 - 12, 1998
of the Swiss Society of Earthquake Engineering and
Structural Dynamics (SGEB)**

Thomas Wenk
Corinne Lacave
Kaspar Peter

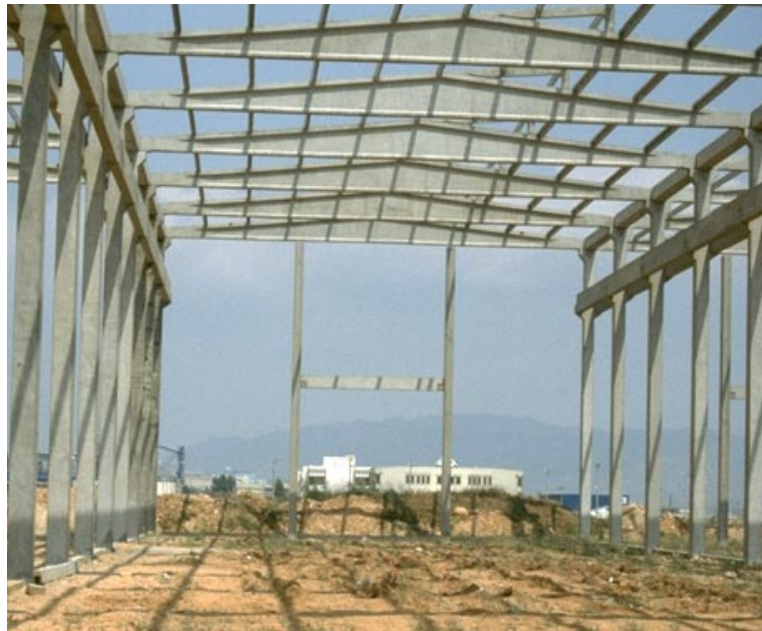
Fig. 24 Typical industrial buildings under construction showing precast reinforced concrete pin-connected frames

Factories and warehouses were often built of precast reinforced concrete elements. The columns were fixed at the foundation and the beam-to-column connections were pinned, as shown in Fig. 24. The span width varied between 15 to 25 m. Metal sheeting formed the roof. The side walls were made of masonry infills or metal sheeting.

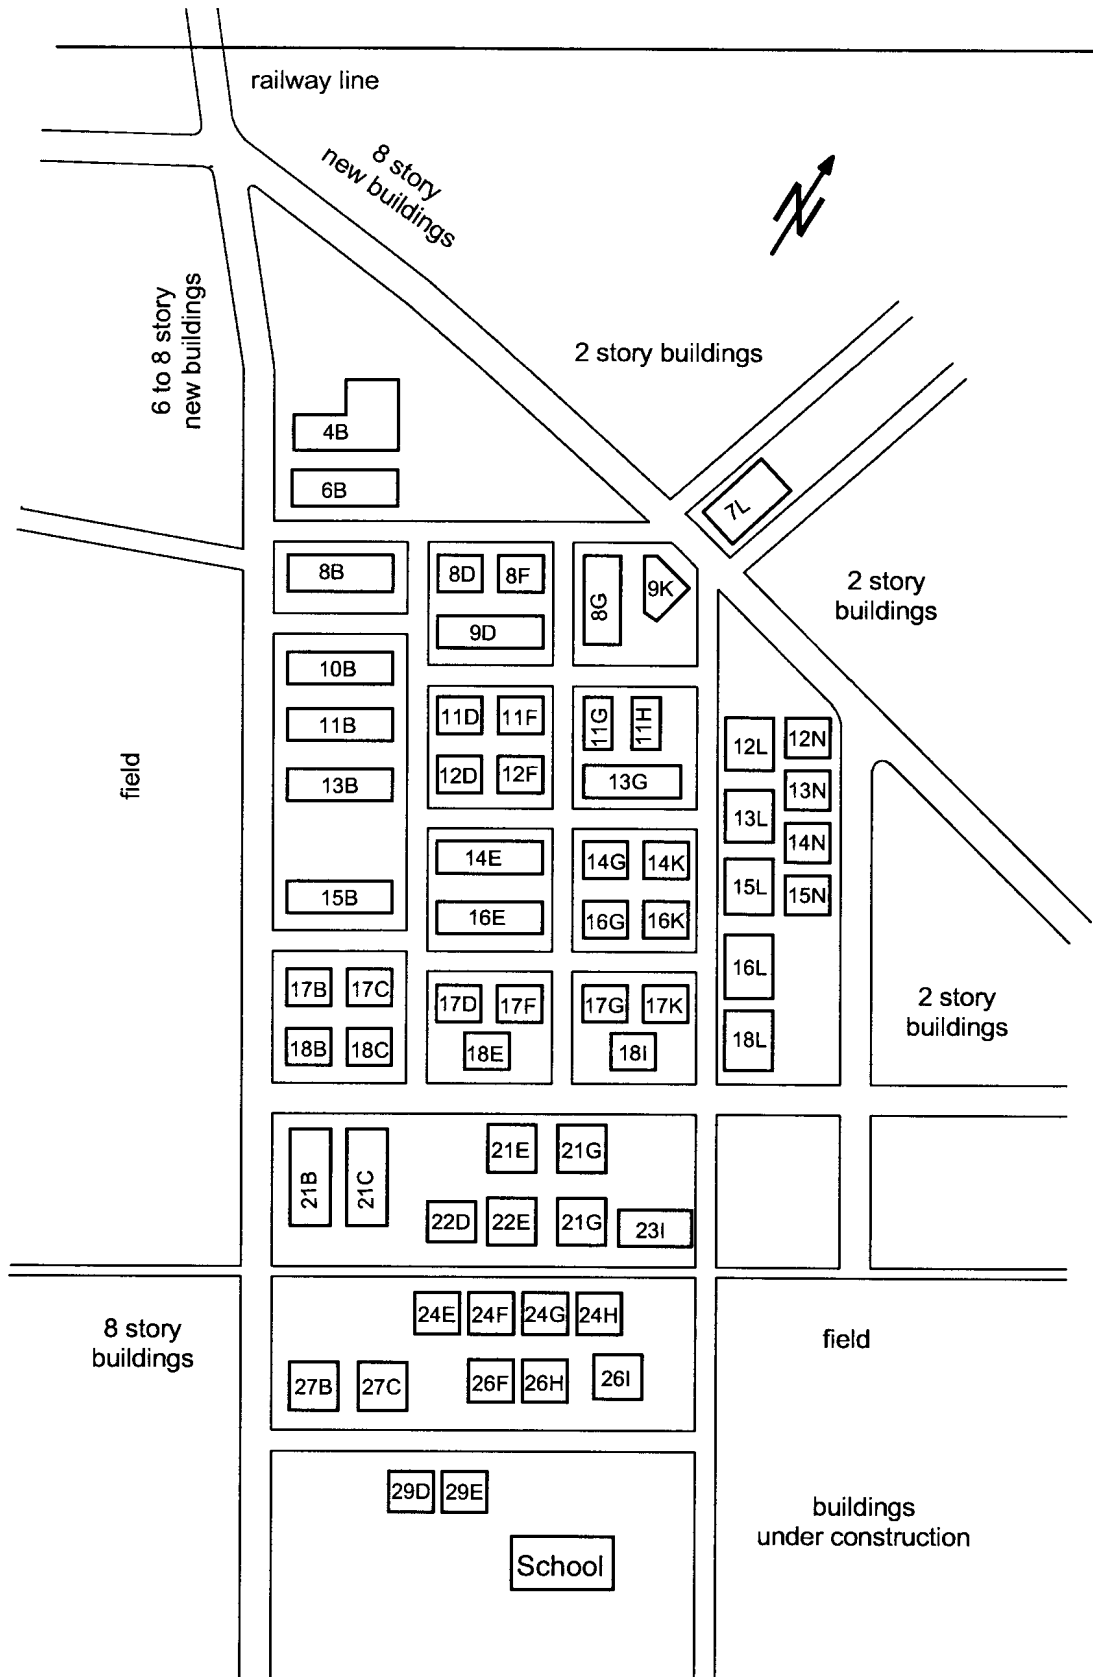
A schematic plan view of the evaluated area is given in Fig. 33. The buildings are represented, in general, by rectangular icons and identification number. From a total of 65 buildings, 43 buildings had 5 or 6 stories; 17 buildings had 8 to 10 stories; and 4 buildings had 4 stories or less. Some of the buildings had a basement which reached up to 1 m above the surface.

Fig. 33 Schematic plan view of Cumhuriyet Mahallesi district of Ceyhan showing the 65 evaluated buildings

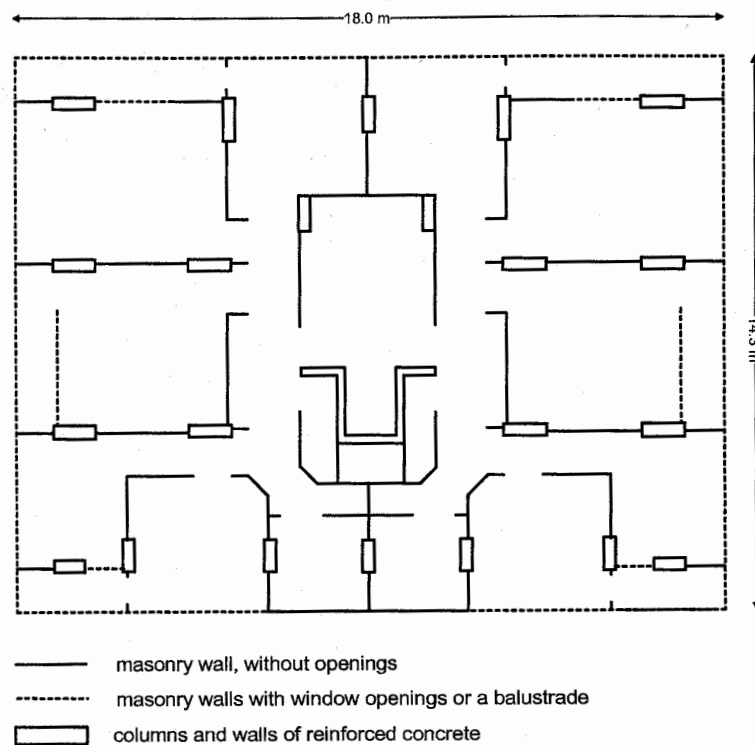
Fig. 37 Plan section through an upper story of a typical residential building; in the first story, the masonry infill walls were often replaced by openings

- Columns with wall-like rectangular cross section 0.80 m to 1.10 m long and 0.30 m wide, oriented in the principal building directions (see Fig. 37). Vertical reinforcement bars were \varnothing 14 mm with $s = 150$ mm, corresponding to a reinforcement ratio of about 0.6%. The confining reinforcement consisted of \varnothing 8 mm stirrups spaced at 330 mm (0.1%).

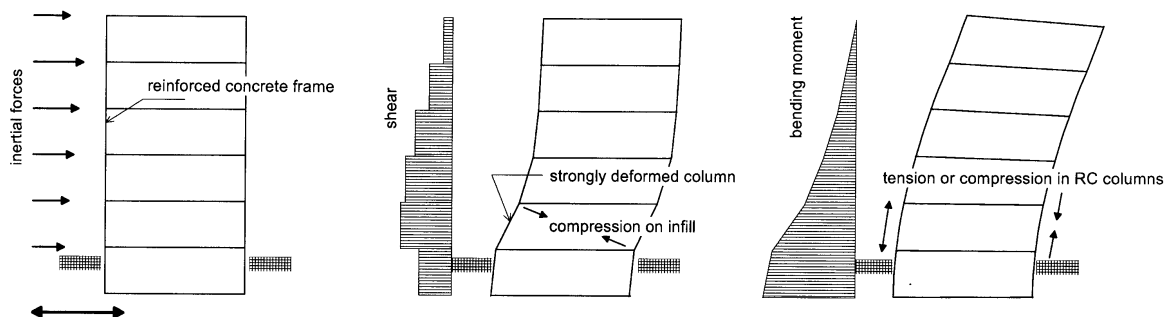
The typical damage pattern can be explained by the specific construction type of the residential buildings. Under gravity loading, the reinforced concrete frame takes all the forces and the masonry infills are not stressed. Assuming a regular stiffness and mass distribution over the height of the building, the horizontal earthquake forces are distributed as shown in Fig. 38 on the left. The resulting shear forces are highest in the first story (Fig. 38, in the middle). As a consequence, the largest horizontal story deformations occur there, too. Due to the horizontal column deformations, the stiff masonry infills are quickly loaded to their ultimate capacity and fail in a brittle manner. The more flexible and ductile reinforced concrete frames have a larger deformation capacity and remain intact longer. Due to the progressing damage of the masonry infill walls in the first story, the building softens in this story resulting in a base isolation effect. As a consequence, the upper stories will be somewhat isolated from the ground excitation and exposed to reduced horizontal accelerations and reduced shear forces. Less damage could be expected in the upper stories compared to the first story.

The building is not only stressed by shear forces but also by bending moments (Fig. 38 on the right). The deformations due to the bending moment are smaller than the shear deformations and are essentially carried by the concrete frames.

Fig. 38 Behavior of reinforced concrete frame buildings under seismic action: horizontal earthquake forces (left); resulting shear forces and corresponding deformations (middle); resulting global bending moments and corresponding deformations (right)
